Peter Williams  
Dinosaur National Monument  
August 5, 2012

#### A NEW ROCK FALL AT THE TOP OF WARM SPRINGS RAPID

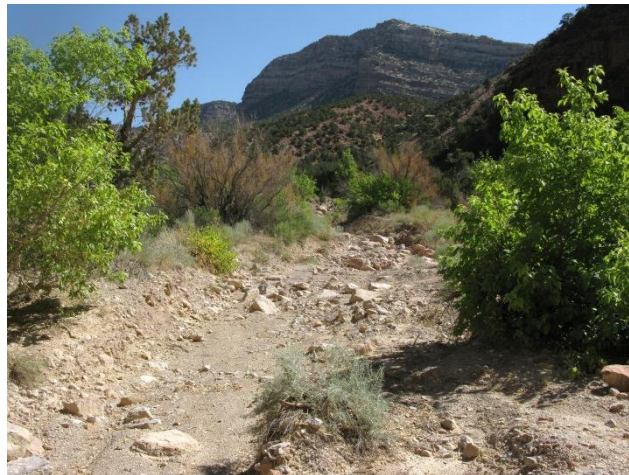
Our first impression was that Warm Springs Draw had experienced a recent flash flood event, adding some new debris to the upper reach of the rapid. We'd seen evidence of recent flash floods in a number of drainages upstream, so it was no surprise to find such evidence here. But we quickly recognized that the relatively small flood event from Warm Springs Draw couldn't account for all of the devastation—and the size of the new boulders—on both sides of the river.

The recent flash flood channel on the Warm Springs debris fan, photographed August 3, 2012.

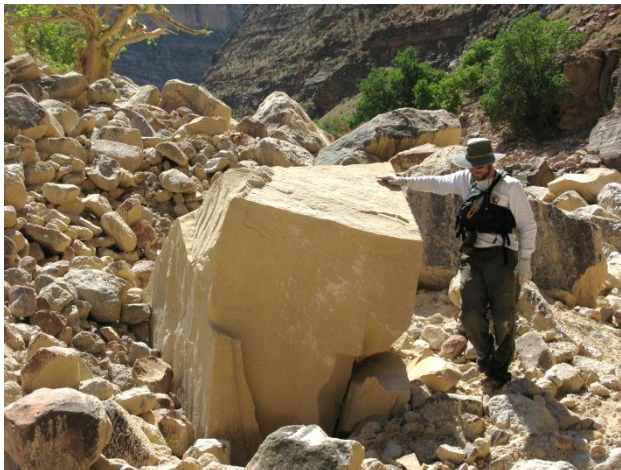
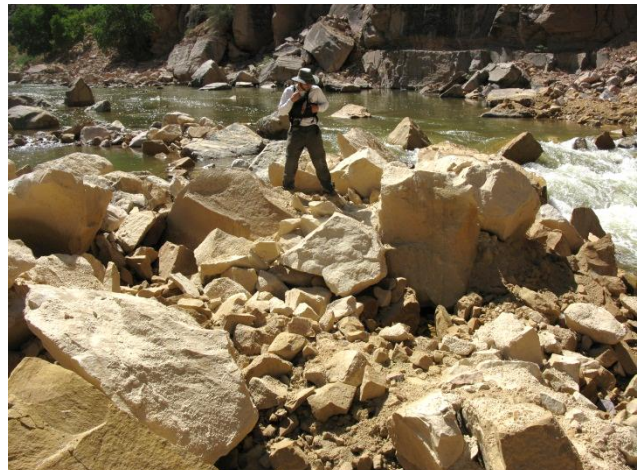
Large, square-cut Weber sandstone boulders embedded in and on top of the older, rounded debris-flow material. Note the apparent impact crater at river's edge in the upper left of the right-hand photograph.

Not only were many of the fresh boulders too large relative to the size of the new flash flood channel, they were all recently fractured into flat planes and sharp edges, indicating that they had not travelled any distance in a debris flow. We soon noticed that the several shattered box elders in the vicinity of the devastation were all arranged with their broken trunks and branches angled uphill away from the rapid, in the opposite direction of the flash flood waters. Many of the trunks of these trees were coated with up to a half inch of dried mud—often extending up to ten or twelve feet above the ground—with most of the mud caked on the sides facing the river. Many of the boulders in the rapid, both the older landmark features we were familiar with and the new additions, were coated with this mud layer, but typically only on vertical surfaces facing the center of what was clearly an impact zone. Mud was also splattered on rocks and trees up to a hundred feet or more from the impact zone.

Another distinct feature is an apparent impact crater on the edge of the water, immediately upstream of the major rubble pile. We can understand no dynamic that would have created this deep, circular pit except perhaps that an extremely large block of rock landed here before bouncing out and shattering into the new rubble now piled next to the crater.

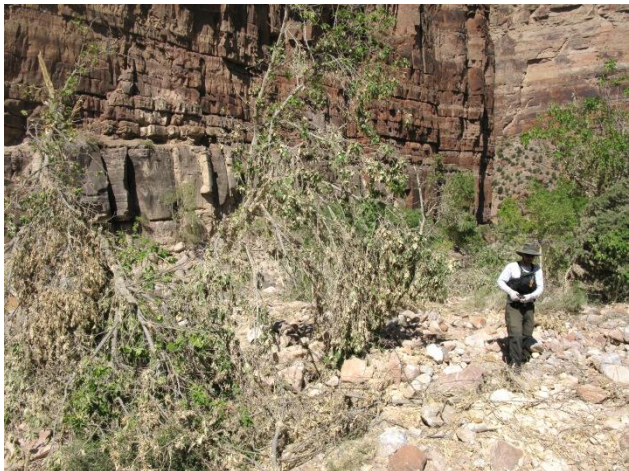
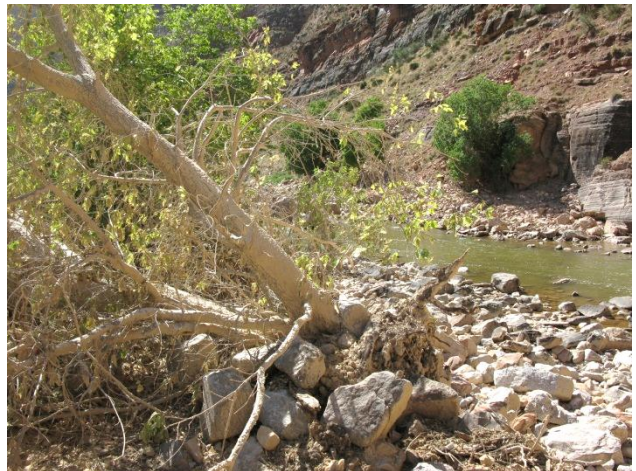
Broken box elder trees, with the broken limbs and trunks pushed uphill away from the rapid, in contrast to the direction of the flash flood flow.

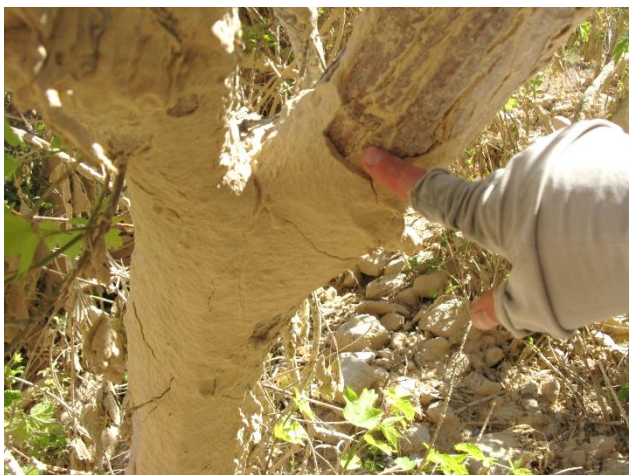
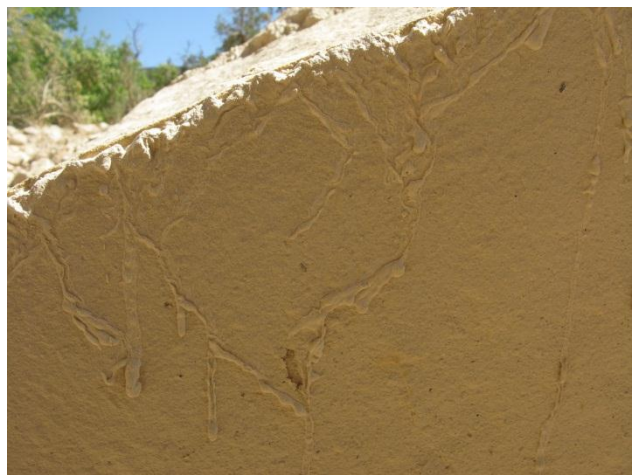
Mud deposited on tree trunks and boulders. The right-hand photograph shows the riverside face (next to Chris) of the large boulder shown in the left of the pair of photographs on page 1. The conspicuous lack of mud on the other surfaces of this boulder was striking.

Several details about this event continue to mystify us. The caked mud clearly extends up the trees along the edge of the rapid far too high to have been the result of pooling water from a temporarily dammed river. Clearly there must have been some minor damming of the river during these events, but we saw no evidence of new sediment and rock washed into the lower half of the rapid, a condition we would expect after a larger dam was subsequently breached. In addition, the mud deposits farthest from the impact zone often appear to have rained down on the top surfaces of the preexisting debris fan material, rather than having been deposited by flood waters. Yet the existence of large boulders with thick mud deposits only on a single vertical face, especially evident on the large boulder shown on page 1, suggests there was more to this dynamic than simply a rain of splashed mud after the impact. Perhaps the mud on the boulder in the photograph was originally accumulated in the fracture that eventually failed, creating the rock fall in the first place, and the clean faces of this boulder are the result of fracturing after impact. However, this would still leave unexplained the distinct, one-sided vertical coatings on several of the large boulders out in the rapid, most of which predate the rock fall.

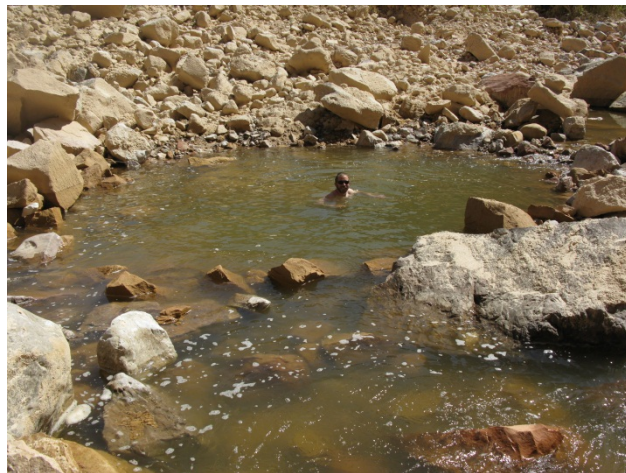
Chris takes depth measurements in the apparent impact crater at river's edge.
