Peter Williams  
Dinosaur National Monument  
August 5, 2012

#### A NEW ROCK FALL AT THE TOP OF WARM SPRINGS RAPID

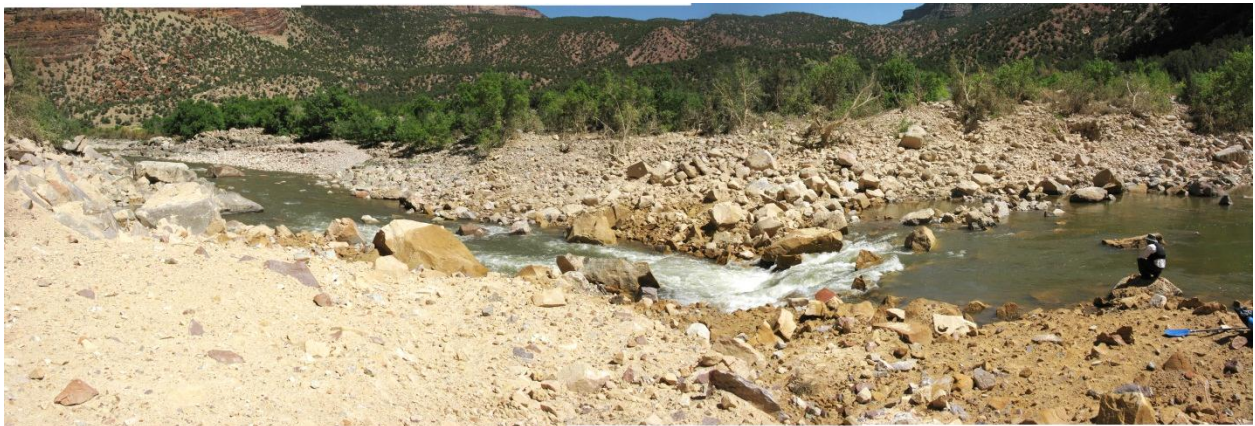
The majority of the large, square-cut rock rubble is now piled on the river-right side of the rapid, just downstream of the point where boaters typically make their move to cut through the lateral waves at the top of the rapid. Even if next spring's high water begins to settle and rearrange these boulders, it is likely that they will provide a new hazard to boaters making this

crucial maneuver—in the form of a new hole or, at the very least, by the addition of several very sharp rocks with the potential to cut boat tubes. The new accumulation of large rock presently creates a steep drop of approximately six to ten feet over a fifty- or sixty-foot section of the rapid. In past years at low water I have observed a similar short, steep drop in the river at this spot, but the gradient seems now to have been increased, with more pooling upstream.

On the opposite side of the river there is now a large accumulation of smaller rock and fine debris, which is less likely to impact the rapid and will probably erode quickly in higher flows. This debris appears to me to have also been part of the rock fall, rather than a result of the flash flood down Warm Springs Draw. I believe the smaller material landed closer to the base of the cliff, while the larger blocks bounced away from the cliff during their descent. Small amounts of the same fine material occur on ledges several tens of feet above the main accumulation at river level, and small box elder on one of these ledges has been completely stripped of its leaves and branches.
